# ANNUAL REPORT FOR 2006

**Little River Bridge Mitigation Site  
Moore County  
TIP No. R-0210A**

Natural Environment Unit & Roadside Environmental Unit  
North Carolina Department of Transportation  
December 2006

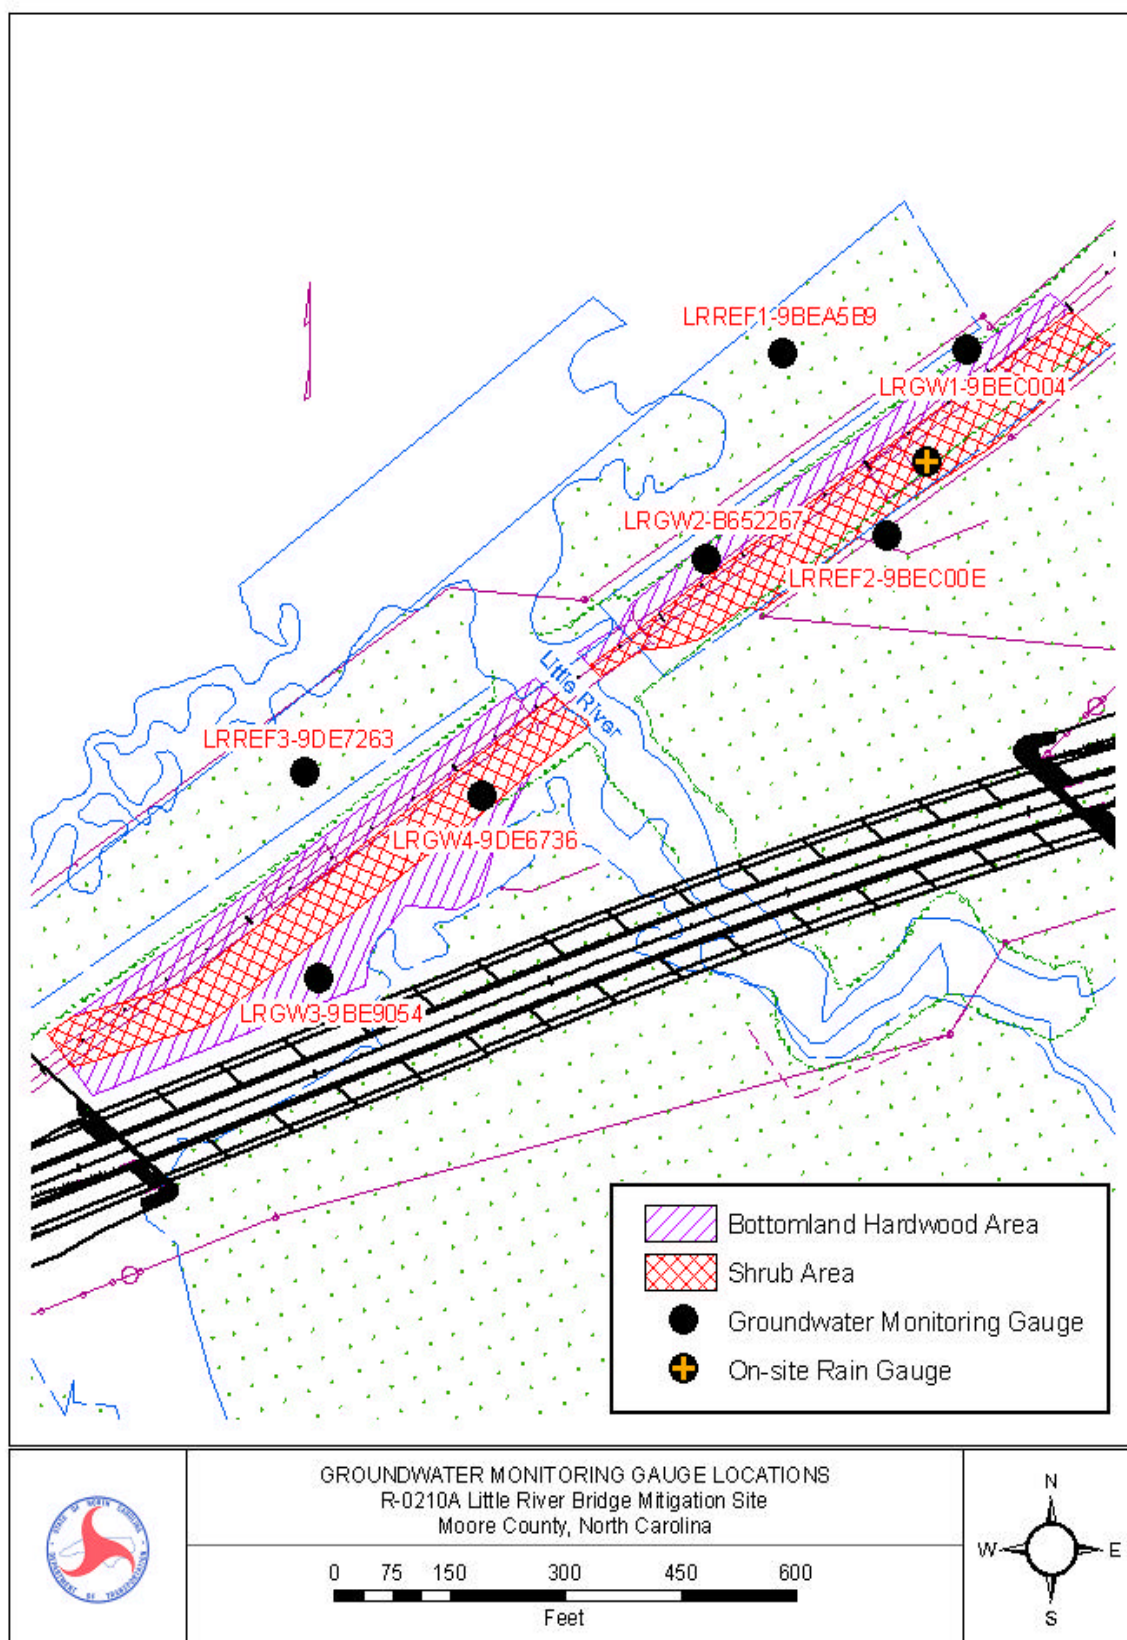
**Figure 2. Monitoring Gauge Location Map**

Four groundwater monitoring gauges were installed within the sites restoration area (Figure 2) in February 2006. There are also three reference gauges that were installed prior to construction in the existing wetlands that are adjacent to the constructed site. A rain gauge is also located on the site to assist in comparison of the rainfall data (supplied by the NC State Climate Office) from an official weather station in Southern Pines. The groundwater gauges record water levels on a daily basis. Monitoring data for 2006 represents the first year of hydrologic monitoring for the site.

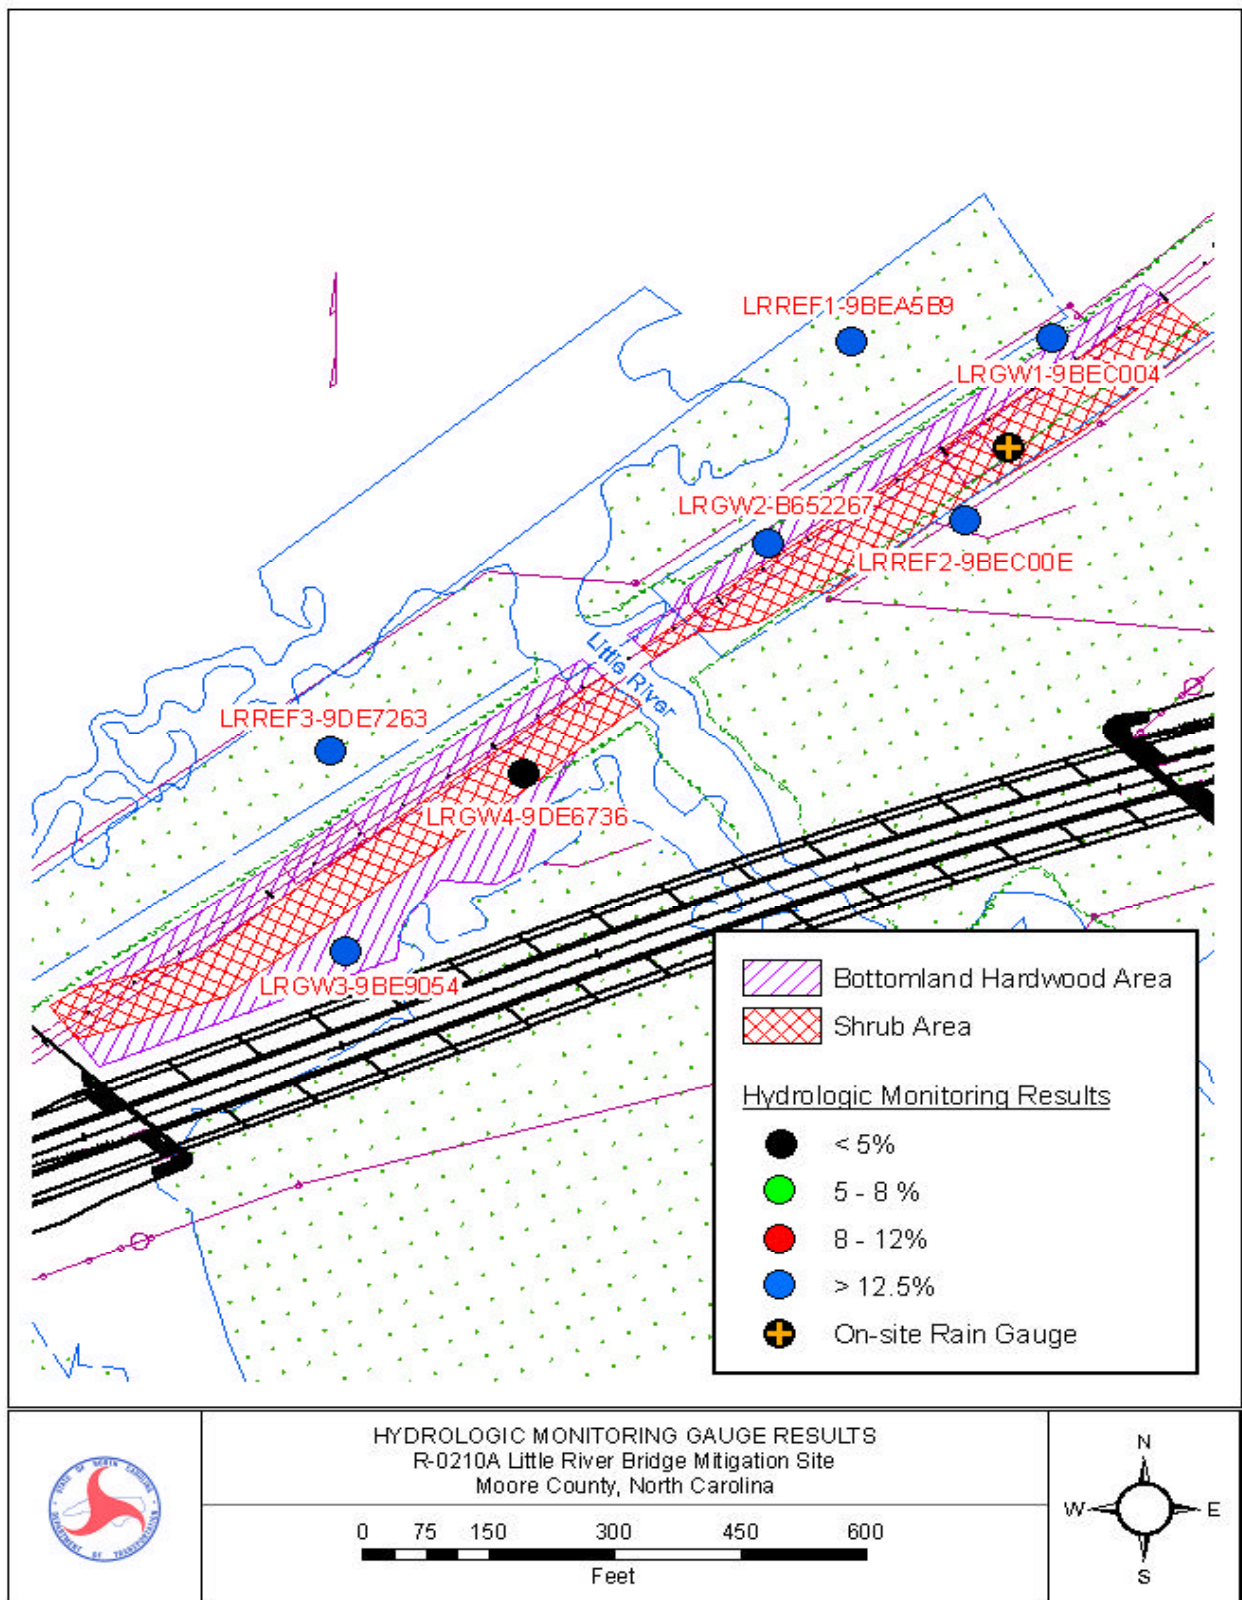
**Figure 3. 2006 Hydrologic Monitoring Results Map**

The maximum number of consecutive days that saturation occurred within 12 inches of the ground surface was determined for each groundwater-monitoring gauge. This number was converted into a percentage of the 228-day growing season (March 23 – November 7). Table 1 provides the 2006 hydrologic results; Figure 3 is a graphical representation of these results. Appendix A includes graphs of the data recorded at each groundwater gauge. Daily rainfall events recorded at the onsite rain gauge (and supplemented by the data from the official weather station in Southern Pines) are included on each of the groundwater gauge plots.

Groundwater Monitoring Gauge 4 is the only monitoring gauge that has not been successful in 2006. The close proximity to the Little River may be causing a draw-down effect on the gauge. NCDOT will continue to monitoring this gauge and may install additional gauges if necessary to determine whether or not wetland hydrology is present in this portion of the site.

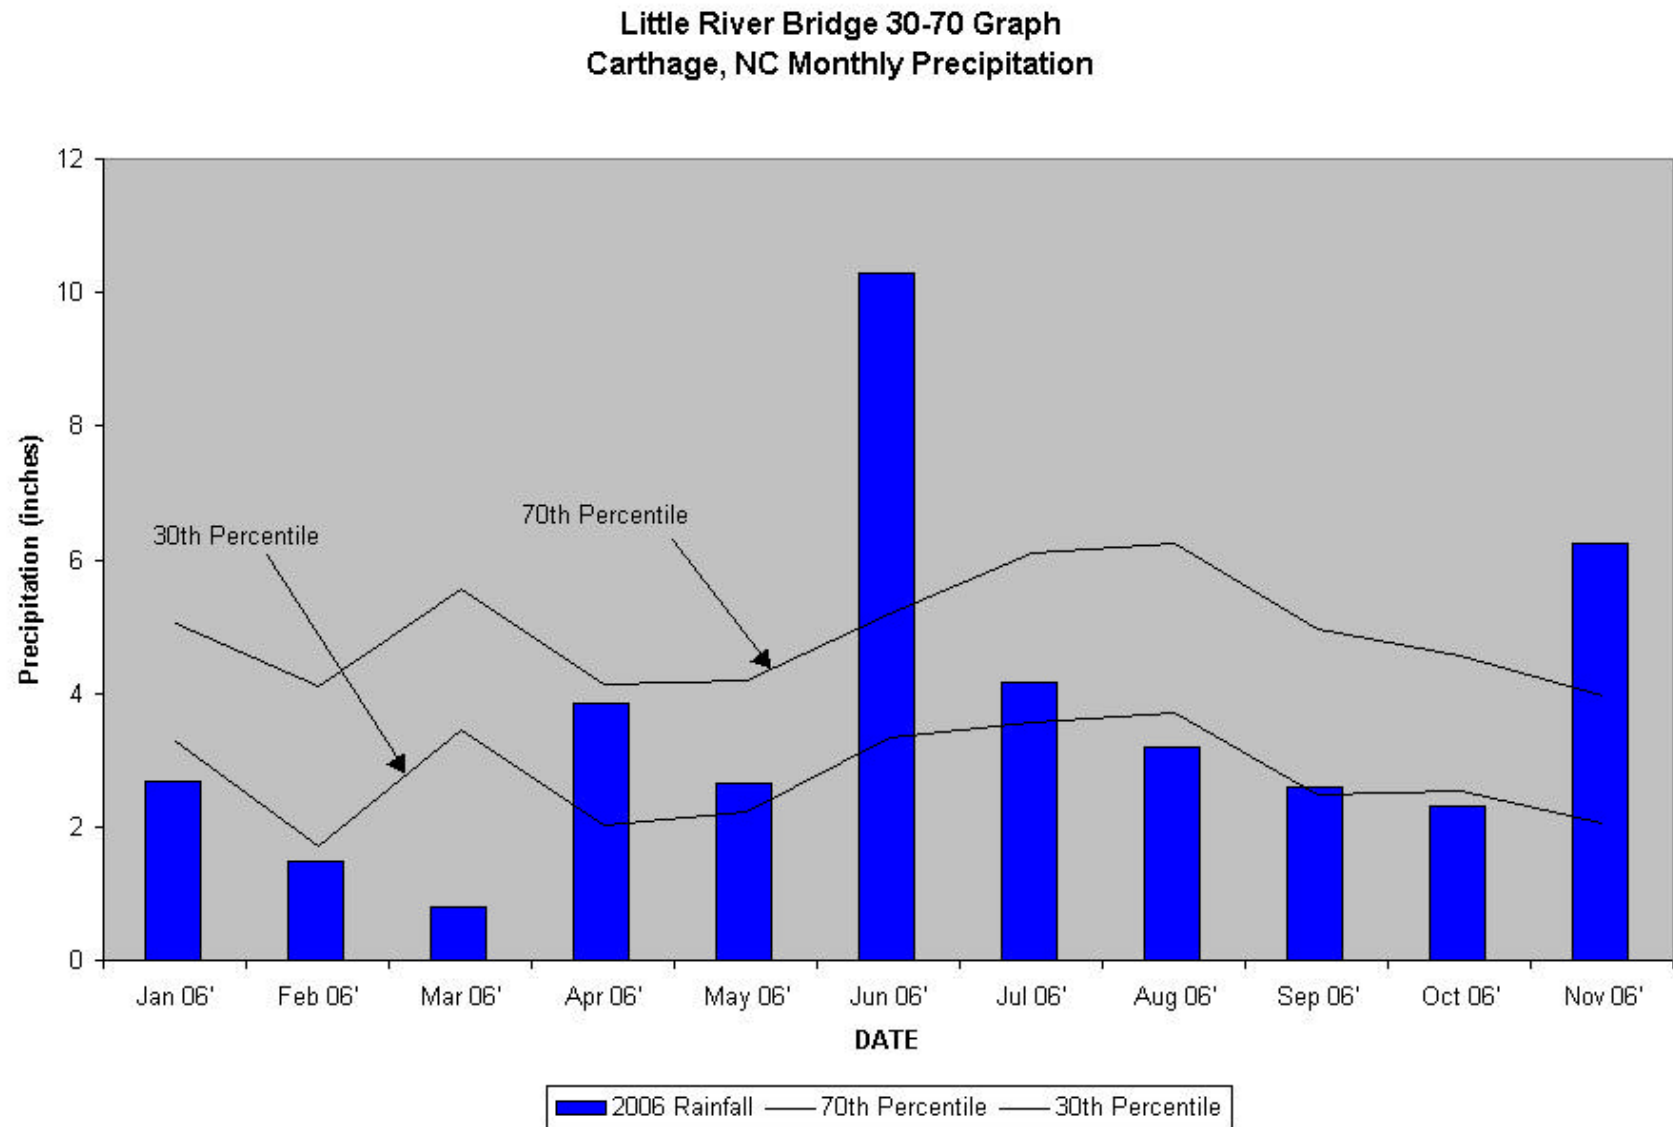
**Figure 4.** 30-70 Percentile Graph, Raleigh, NC

Figure 4 is a comparison of the 2006 monthly rainfall to the historical precipitation (collected between 1976 and 2006) for Carthage, North Carolina. This comparison gives an indication of how 2006 relates to historical data in terms of climate conditions. The NC State Climate Office provided all local rainfall information.

This graph is used to indicate the general precipitation conditions for the surrounding area. Overall, the 2006-year exhibited below average rainfall. The data obtained for the 2006-year indicates that rainfall going into the beginning of the 2006 growing season (January to March) as well as August, September and October tended to be on the low side of normal. The rainfall for the months of April, May and July were normal while the rainfall for June and November were well above normal.
